# Bulletin

**SUBJECT:** FLX-4000™ (Dialight®) 12” LED Flashing Light  
Assembly 042975-7

**NO:** 1-06

**CONCERN:** Incorrect component causing false activation of the  
highway crossing warning signals

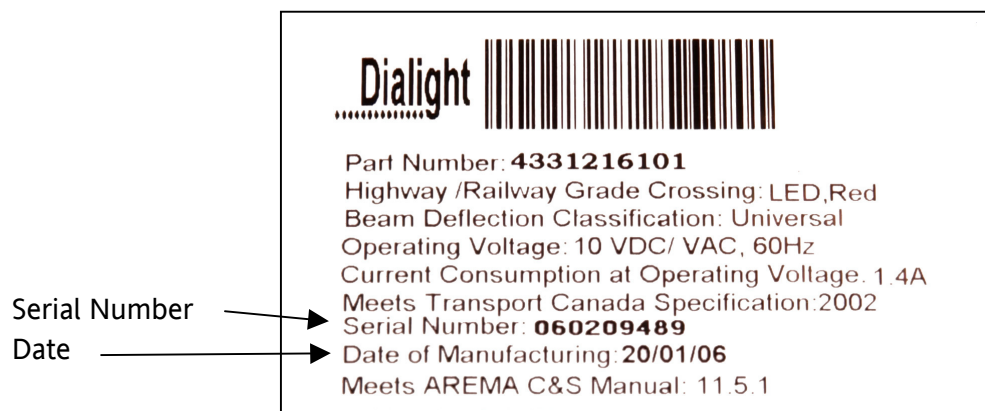
The last five digits of the serial numbers for the affected FLX-4000™ LED assemblies range from 05228 through 06031. These units were manufactured between 16 August 2005 (16/08/05) and 31 January 2006 (31/01/06). The serial number and date of manufacture information is located on a white label attached to the back of each FLX-4000™ assembly. A sample of the label is shown below.

Dialight has agreed that Safetran customers with FLX-4000™ LED assemblies falling within the serial number and date ranges provided above may contact Dialight Corporation directly for an expedited product exchange (see attached letter).

- Verify the serial number and manufacture date of all FLX-4000™ LED assemblies used at the crossing. If any of the LED assemblies fall within the S/N and date ranges specified above, please contact: **Dialight Customer Service Representative Ginger Ablonsky at 732-751-5832 and request an RMA number for all replacement units.**
