Bulletin

SUBJECT: Intelligent Light Out Detector (iLOD), A80271
CONCERN: Incorrectly installed component causing false current readings

NO: 2-06B
DATE: 8-18-2006
Revised
8-29-2006

CLASS / ACTION: Operational / Mandatory

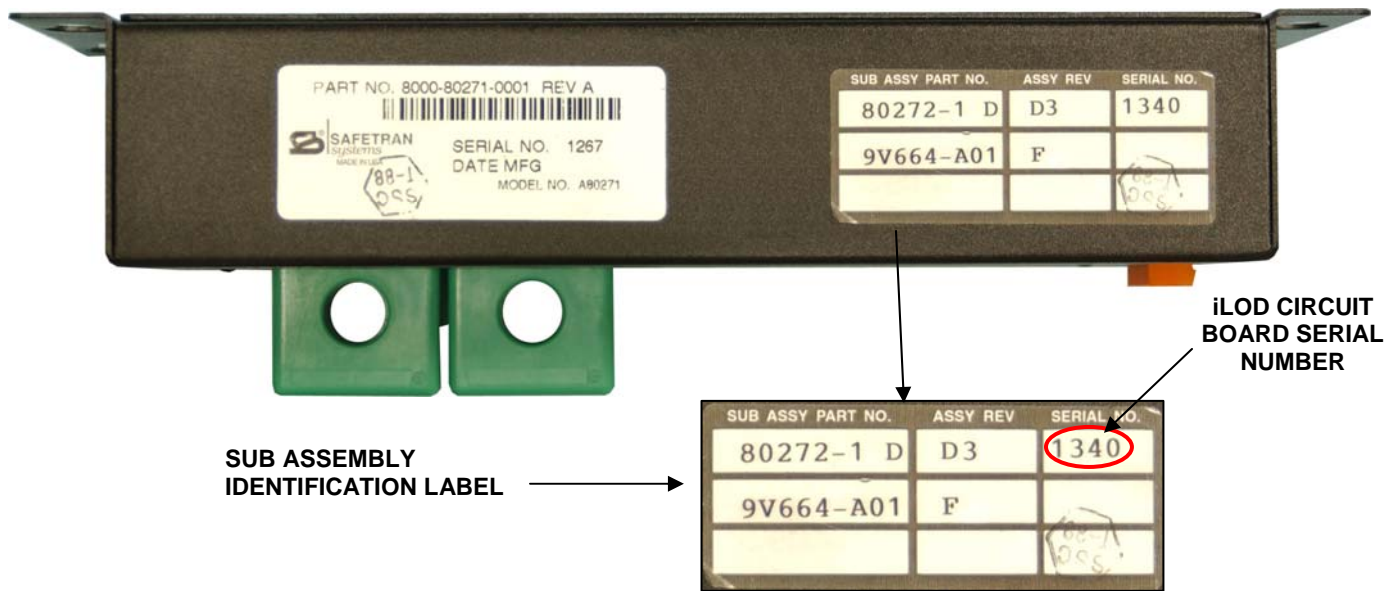
Figure 1. Printed Circuit Board Serial Number Location

The serial numbers for the affected iLOD printed circuit boards range from 3700 through 4700. The serial number is located on a sub assembly identification label attached to the top of each iLOD assembly (see figure 1).

Safetran has established a 'seed stock' of new iLODs. Customers with iLODs in the affected serial number range are requested to order the number of iLODs from seed stock to replace the defective units currently in the field. Once the new iLODs are installed, return the defective units to Safetran through the normal field return process.
